## PROPERTY INSPECTION REPORT

**Surry Hills**  
December 2016  
The Owner's Corporation

The purpose of this inspection was to identify and report on defects in the above property prior to the commencement of building works on the adjacent site

The property is a 6 level warehouse conversion

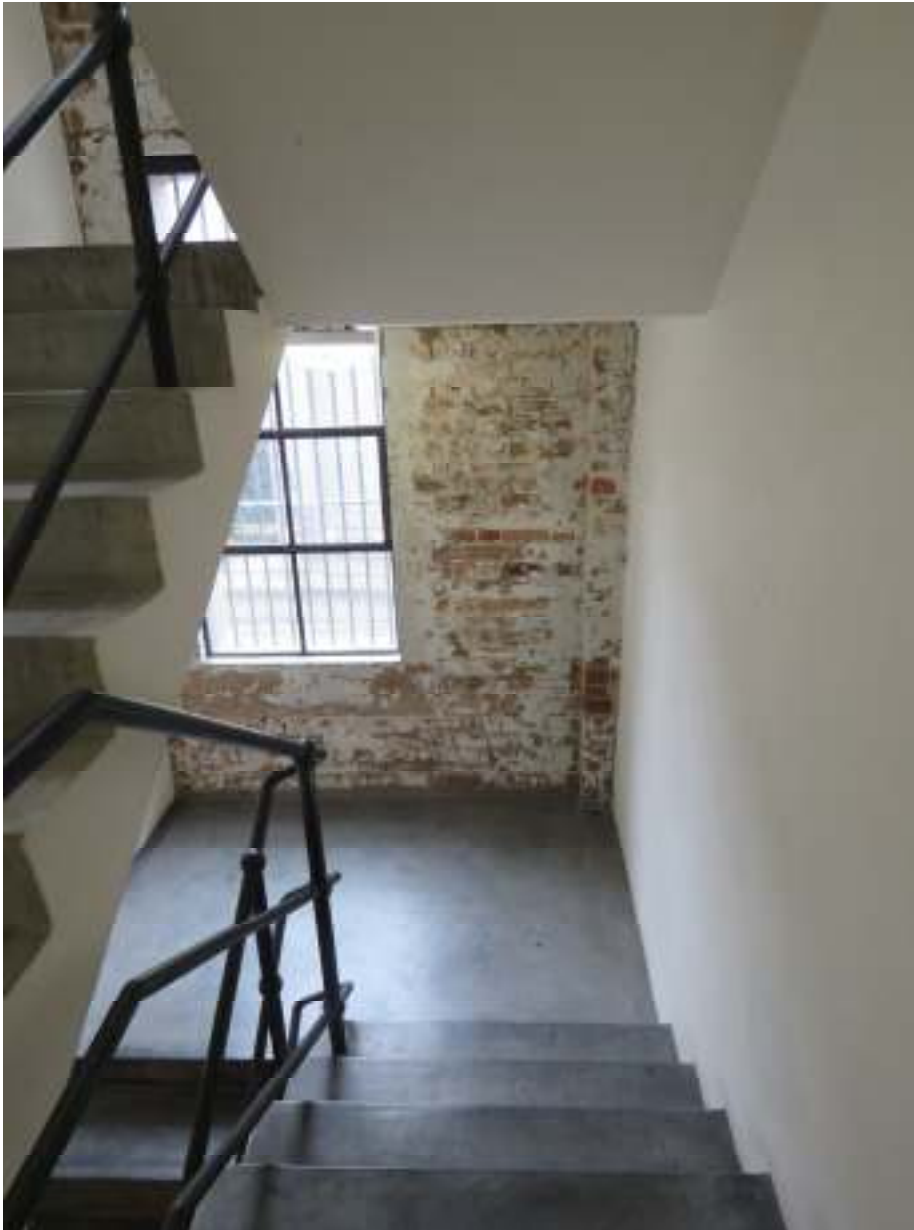
- a. The northern wall has been stripped of paint and shows signs of water penetration on all levels

- b. We noted that there is a considerable amount of water penetration around the original and replaced steel fire windows. We found blistering paint in the reveals and sills, both inside and outside on levels 1, 2 and 3.

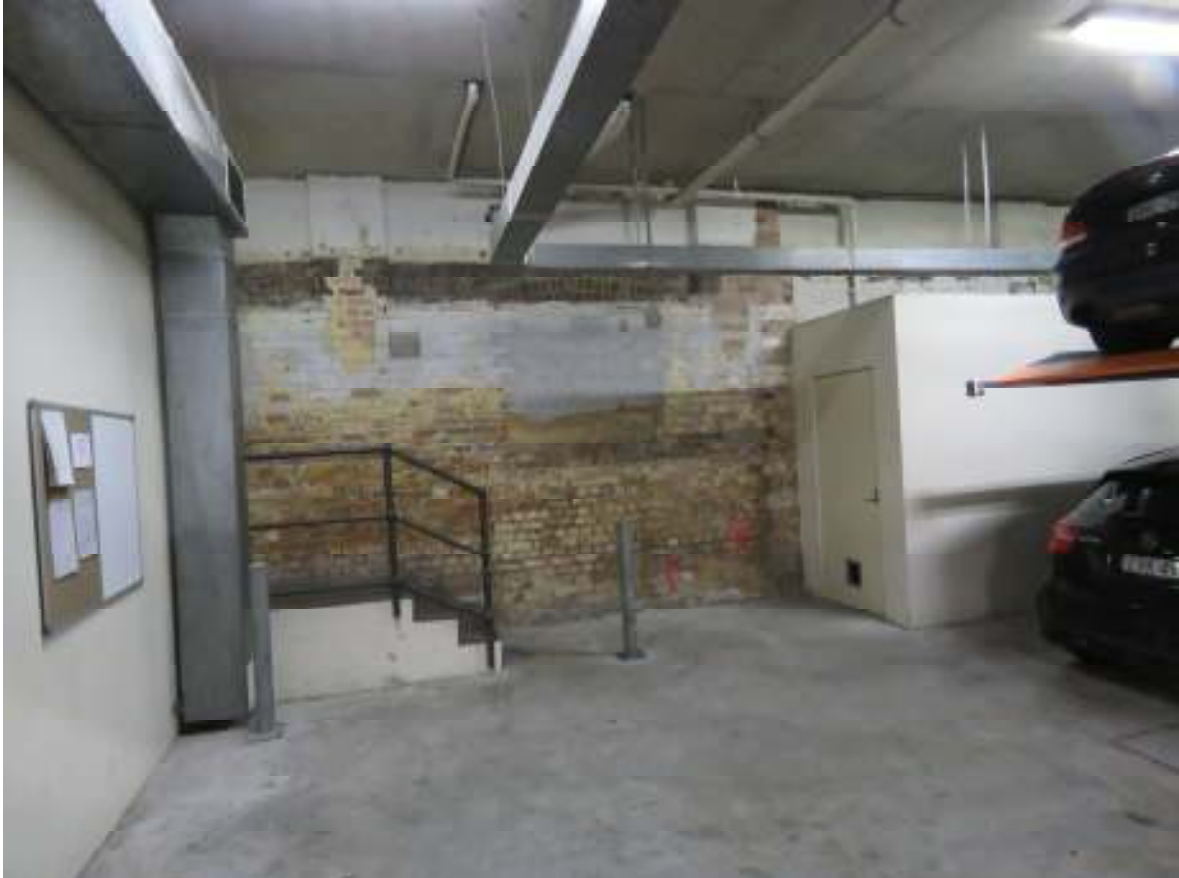
- a. There is some water penetration along the northern walls

- b. Some of the steel door frames are affected by moisture and are rusting
- c. There is water welling up from the cracks in the floor slabs - see comments below

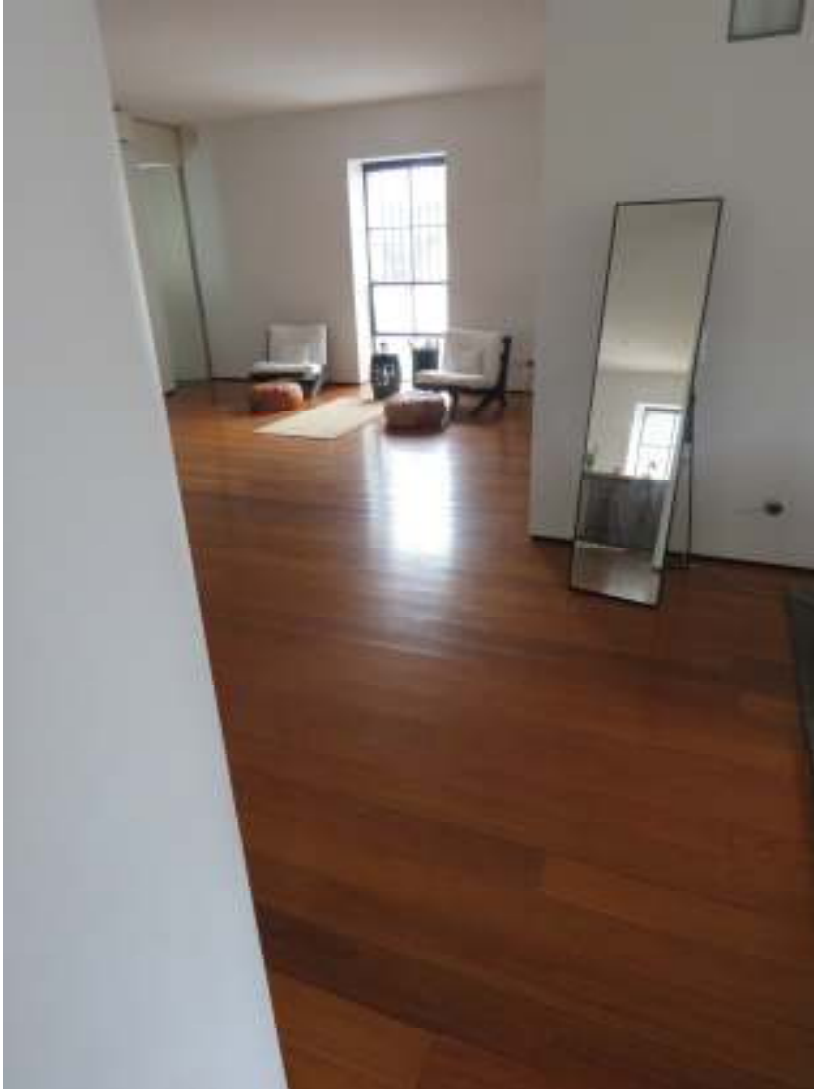
- a. There is some minor cupping in the timber flooring  
This is a common issue in many of the apartments

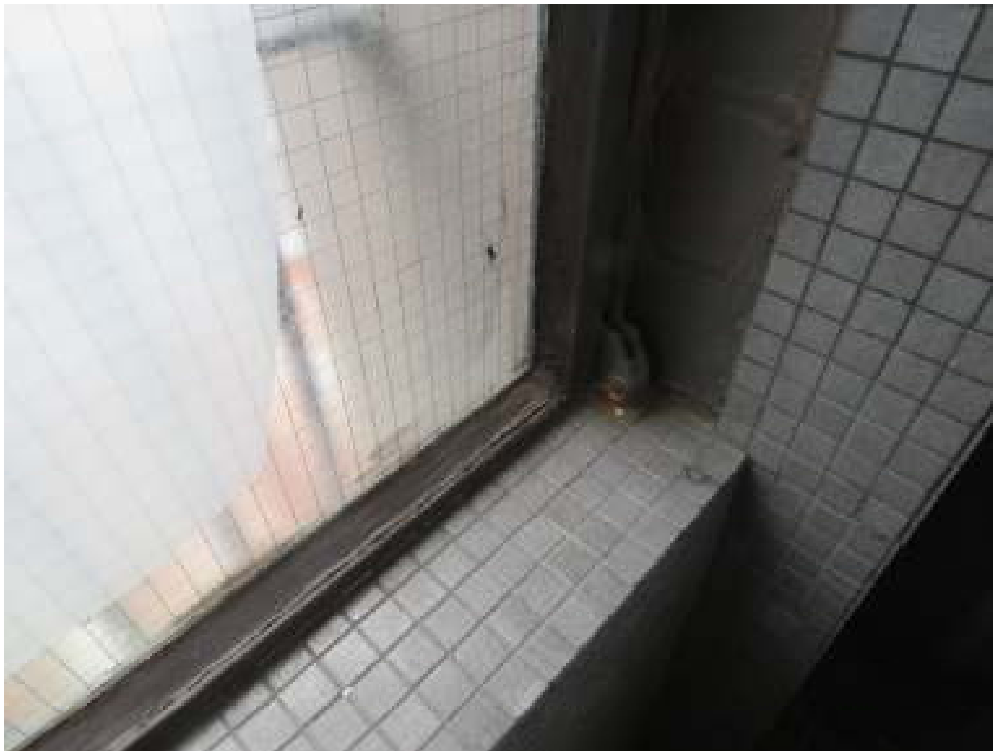
- a. We noted that there is a considerable amount of water penetration around the original and replaced steel fire windows. We found blistering paint in the reveals and sills, both inside and outside

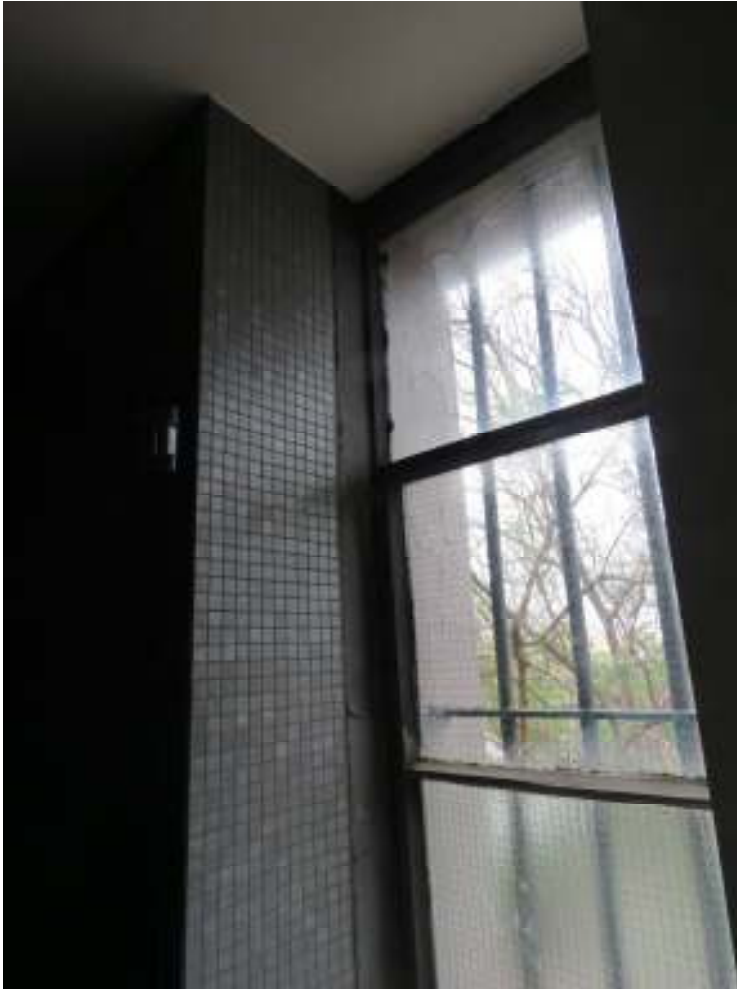
- a. We noted that there is a considerable amount of water penetration around the original and replaced steel fire windows. We found blistering paint in the reveals and sills, both inside and outside

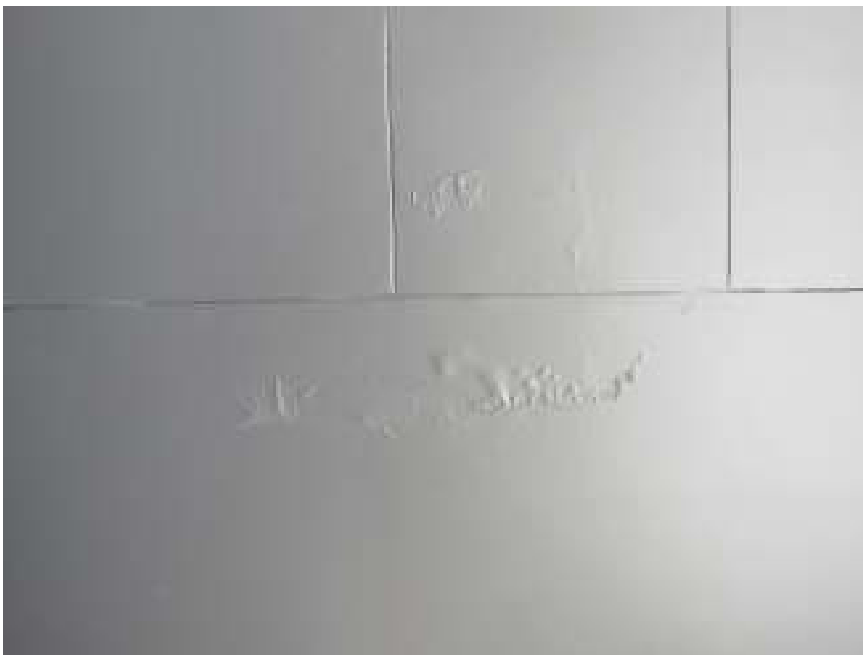
a. There is some minor cracking at control joints and the bearing of slabs on walls

The cracks are hairline, less than 0.5mm wide

The crack zones show some efflorescence and blistering in the paint

We are advised that waterproofing repair works have been recently completed

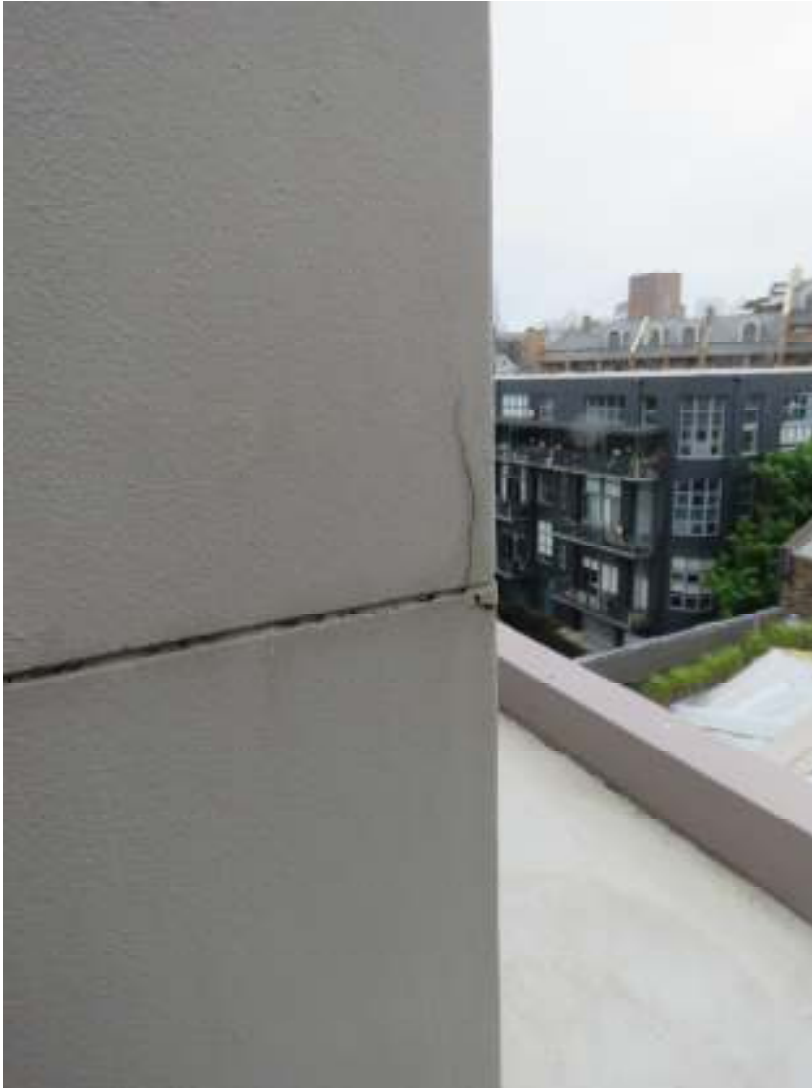
- a. There is some minor cracking at control joints around the lift over run tower  
The cracks are hairline, less than 0.5mm wide

- b. There is some dampness in the base of the lift over run tower and stair walls  
We are advised that waterproofing repair works have been recently completed

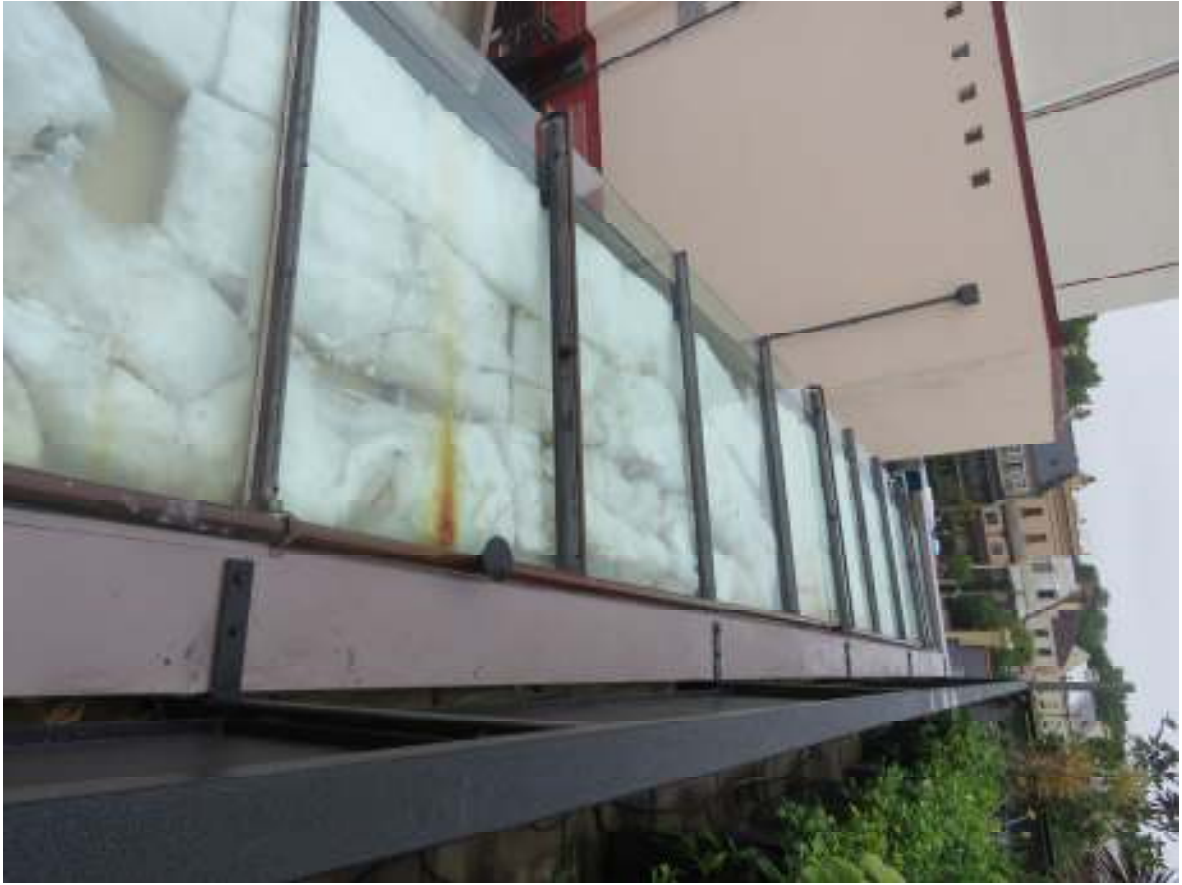
- c. Builders of the adjacent site need to be aware that there is a glass roof running along the northern and the southern side of the building.  
The glass roof is protected by sprinklers

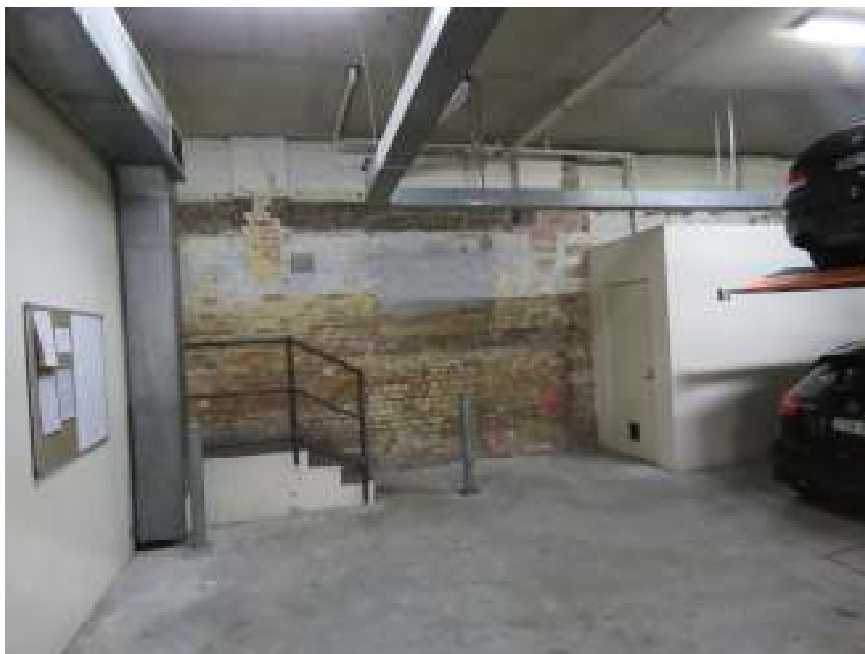
5. The ground floor of the building is a part basement, with the external ground level; of the parking area of the adjacent development site being approximately 1200mm above the internal floor level at the north western corner and about 2100mm above the floor level at the north eastern corner.

There is severe dampness in the northern walls of the carpark and ground floor walls

We are advised that in periods of heavy rain, spouts of water have been found emerging from the rear sections of the northern walls

It appears that the paving of the car park area of the development site is highly porous, a superficial examination of the site shows that the slabs are badly cracked, poorly drained, and are sloping to the south against the walls of the subject property.

The ground under the carpark level appears to be saturated

6. There are many cracks in the carpark floor of No 36. We noted that there is some water staining around the crack lines. This appears to be water pumping up from under the slab due to hydrostatic pressure from the saturated ground under the neighbour's carpark level.
7. In my opinion, the source of the water that is causing the dampness in the parking level of no 35 will be more or less eliminated by the construction works on the development site.

The future basement will need to be tanked to achieve watertight integrity and will be fitted with sumps and pump out systems to remove all seepage water to the street gutters and council drains.

8. As the developers appear to be proposing to excavate to a level lower than the probable depth of the footings of the building at no 36, the excavation and construction works should be monitored by representatives of the Owner's Corporation of No 36
